# ROOF SURVEY REPORT

789 ABC CROSSING LANE ♦ MONEY, GEORGIA

**ZYX**  
*corporation*

**H C G**  
*hart consulting  
group, inc.*

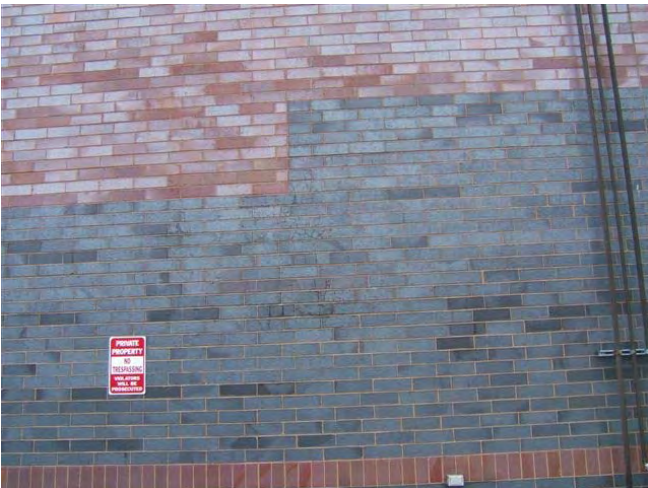
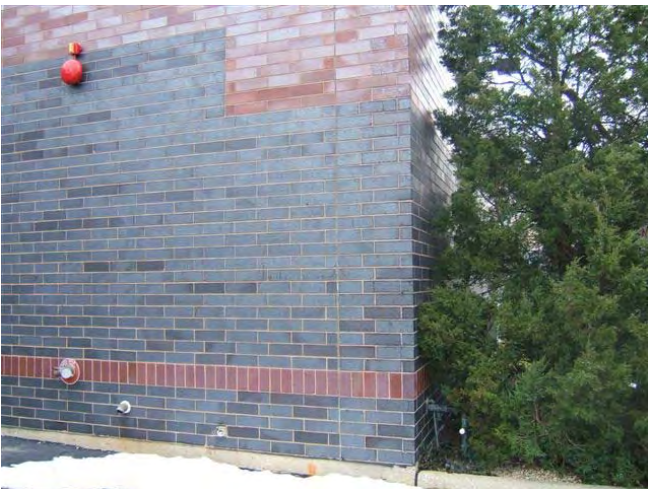
PHOTO #'s 8 & 9  
CRACKS IN THE BRICK FACADE  
AND DAMAGED MORTAR JOINTS

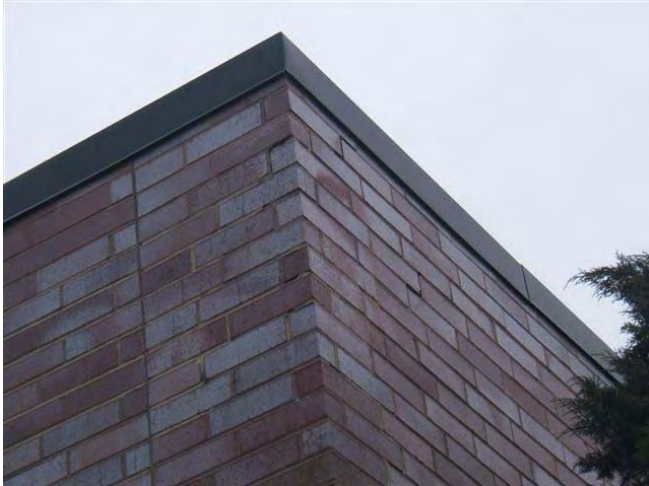
PHOTO # 10

CRACKS IN THE BRICK FACADE  
AND DAMAGED MORTAR JOINTS

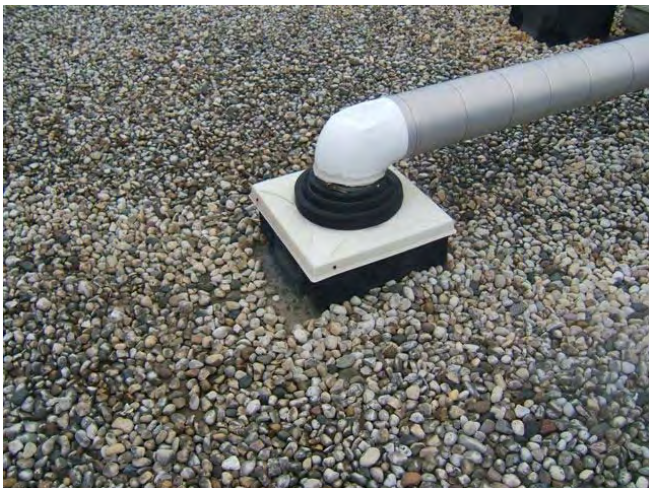
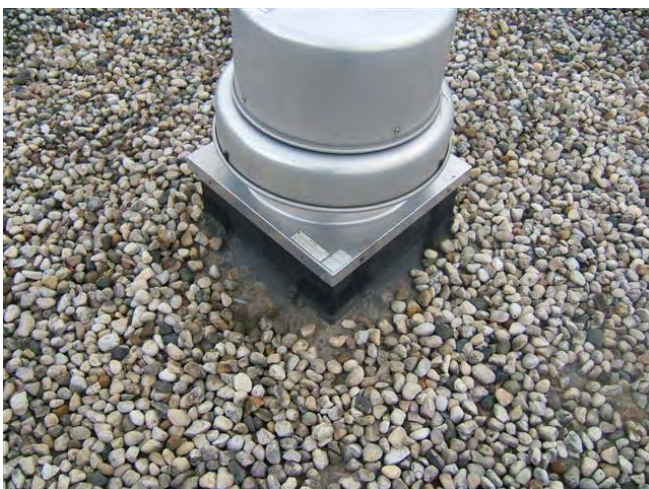
PHOTO #'s 11 & 12

**Comments:** Membrane shrinkage is evident at all flashings with repairs evident.

THE BASE FLASHINGS AND EDGE METAL HAVE  
STRESS DUE TO MEMBRANE SHRINKAGE

The 18-year-old ballasted EPDM should be replaced in the next 18 to 24 months. The system shows membrane shrinkage with stressing seams and flashings at edge details and all penetrations. The membrane will continue to shrink causing stress at all penetrations and edge details with subsequent leaks.

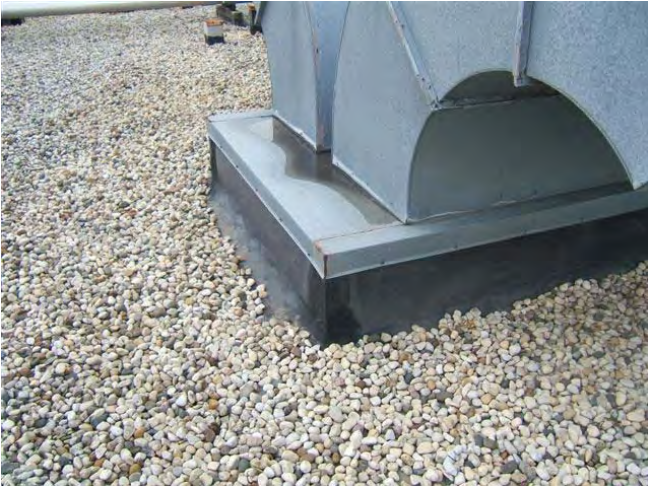
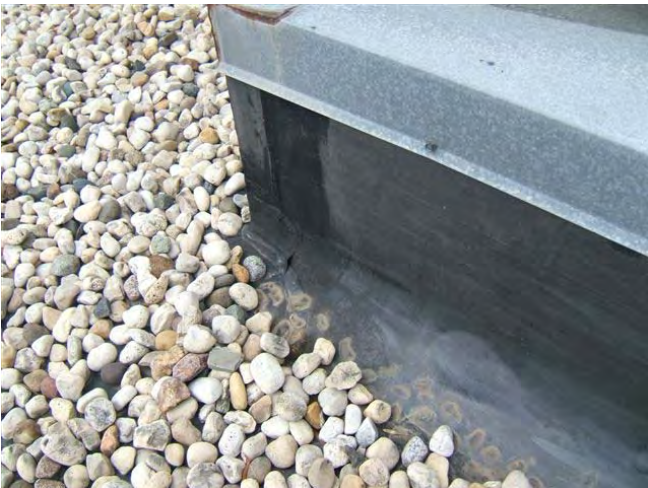
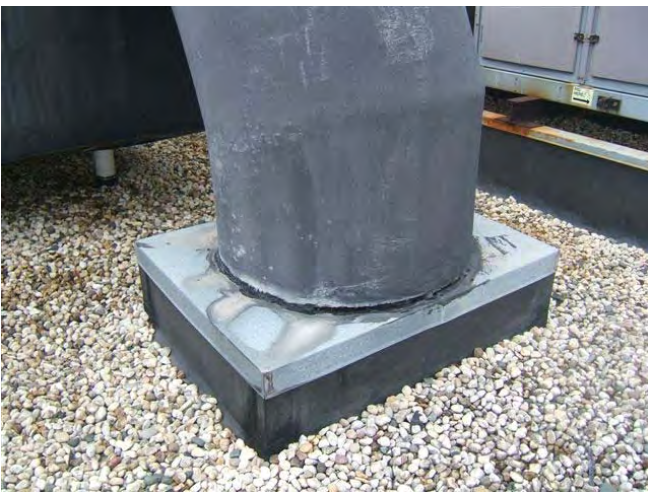
PHOTO #'s 13, 14 & 15

THE BASE FLASHINGS AND EDGE METAL HAVE  
STRESS DUE TO MEMBRANE SHRINKAGE

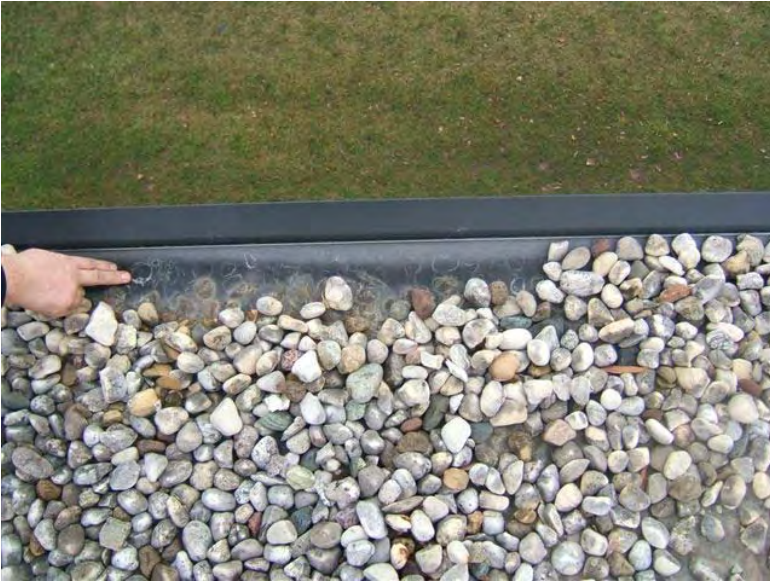
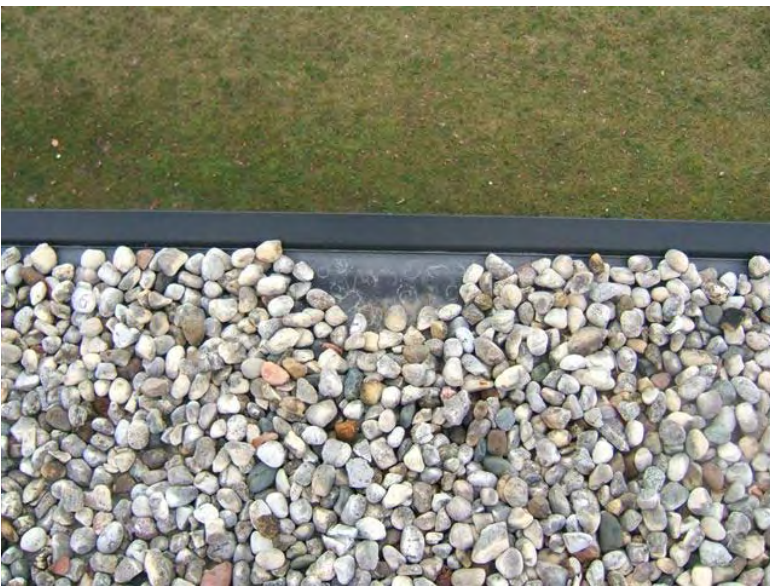
PHOTO #'s 16 & 17

THE BASE FLASHINGS AND EDGE METAL HAVE  
STRESS DUE TO MEMBRANE SHRINKAGE

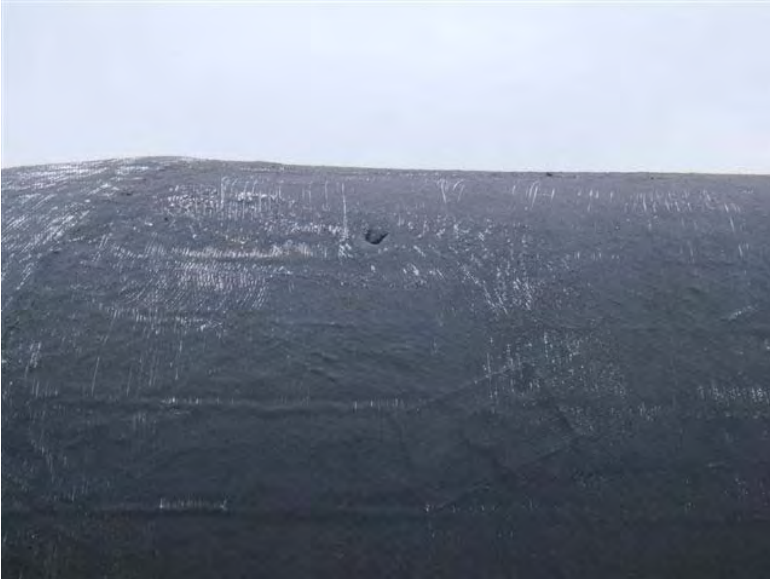
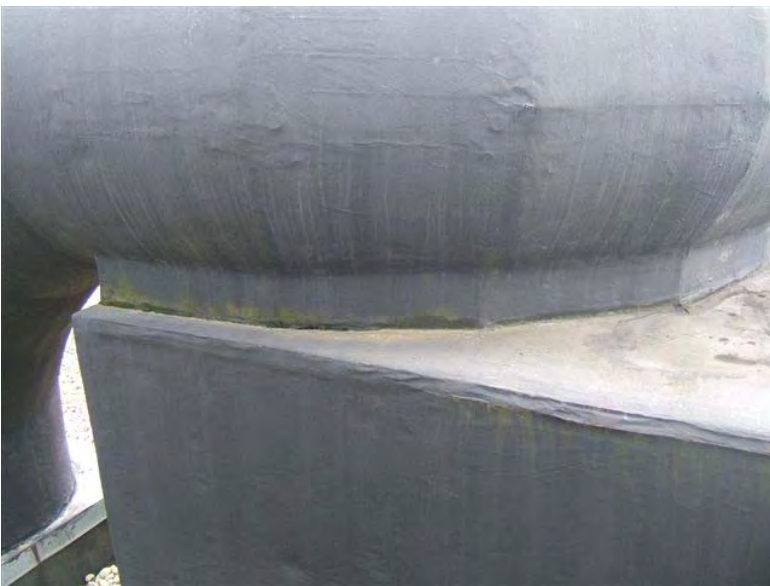
PHOTO #'s 18 & 19

HAIL DAMAGE IS ALLOWING WATER  
INFILTRATION INTO THE HVAC DUCT

| Repair hail damage, apply elastomeric repair and coating to large duct | \$1,200 |
